# Manhole Inspection Summary

Manhole # S23GG\_051MH

**Location** Address: **1620 GILMOR ST**

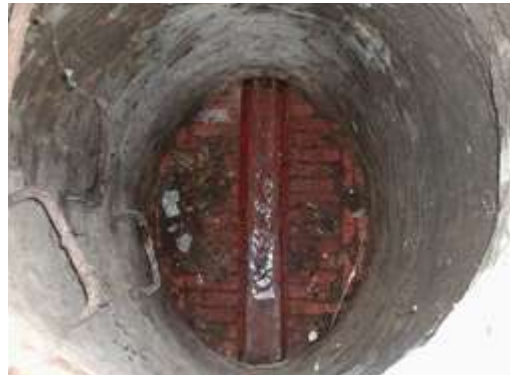
Top View

Corroded steps. Evidence of surcharge - Bench debris.

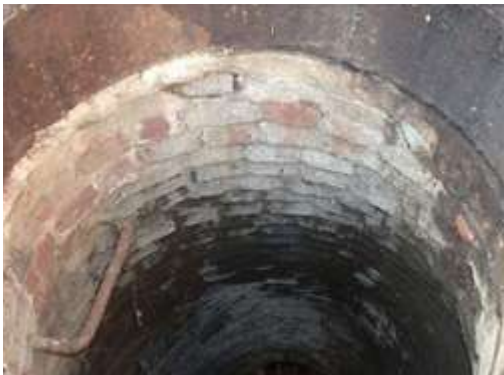
Defect

Frame leaks. Adjustment deterioration and infiltration. Corbel and Barrel infiltration - other side.

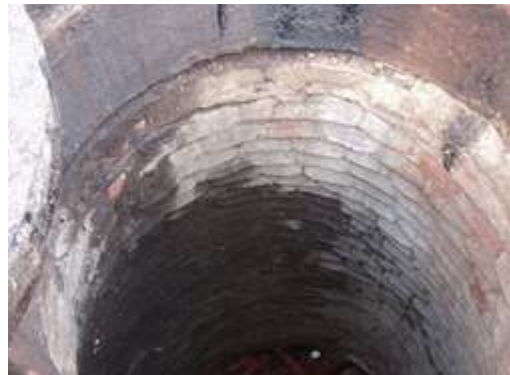
Defect

Frame leaks. Adjustment deterioration and infiltration. Corbel and Barrel infiltration.

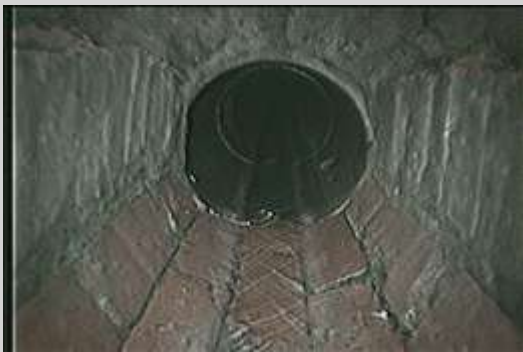
### 8 in. Circular Gravity Sewer Pipe Out @ 12 O'Clock

Infiltration: **Evidence** Pipe Seal Cond: **Cracked**

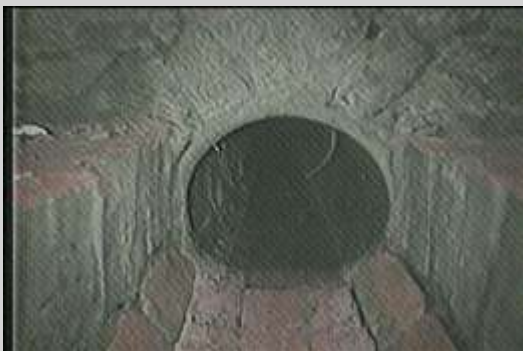
### 8 in. Circular Gravity Sewer Pipe In @ 6 O'Clock

Barrel deterioration and infiltration. Channel deterioration.
